Safety Alert

Number: 16-03

Subject: Small 'Wet Bulk Waste' Spill to Environment

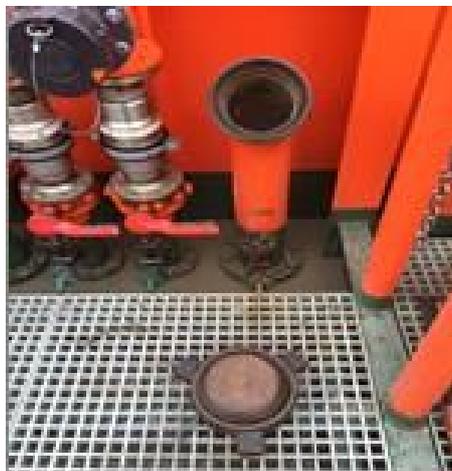
The likely cause to this incident was that the cap was not in place on the starboard discharge manifold following a previous operation. The cap can be seen in situ on the deck immediately after the incident.

The investigation established the vessel had completed the appropriate checklists prior to the operation however; there was a lack of oversight regarding the security of the manifold cap on the opposite side. It was not checked by the ABs, as it was assumed that, as the starboard side discharge manifold had not been used for some time all was in order.

Amend the discharge bulk checklist to include connections, dust caps, save all's, valves on both sides of the vessel (where necessary).
