Safety Alert

Number: 16-11

Subject: Tubular Cargo – Loading Concerns

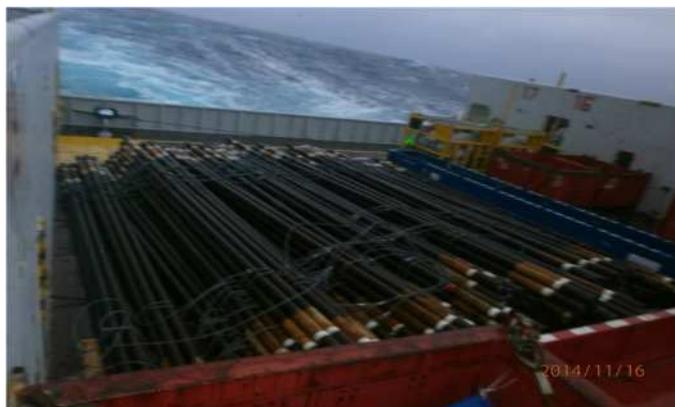
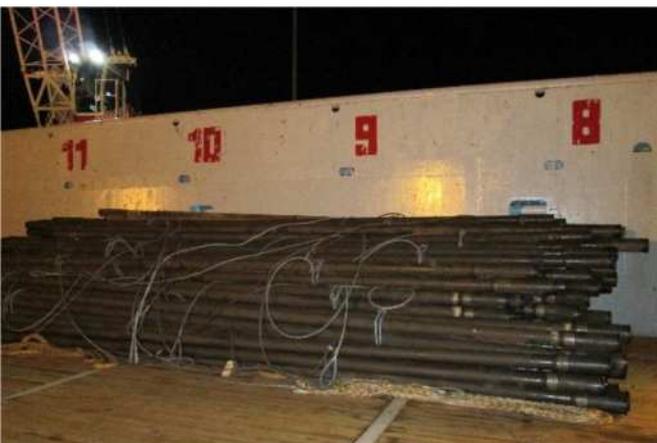
Incident No 1:

A PSV loaded a stow of tubulars in port and although the crew prepared bedding ropes and securing chains they didn't install the pipe bay pins.

As the loading progressed, both the bedding ropes and the securing chains became covered by the tubulars making it impossible for the AB's to secure the stow.

In an attempt to secure the tubulars before sailing a 40 foot basket was placed against the stow and a tugger wire run around the basket.

The vessel then left port and during the passage offshore encountered adverse weather. As the vessel rolled in the seaway the stow of pipes then shifted across the cargo deck.

- Pipe pins should always be put in place for any tubular stow which is expected to extend to the width of the pipe bay and particularly if tubulars are to be 'stacked'.

- Bedding ropes and securing chains should always be used to secure tubulars regardless of the quantity loaded.
- Should circumstances change or a need to deviate from the original plan be required then the changes and their effects should be fully risk assessed prior to the job continuing. If doubt exists 'Stop the Job' should be enforced until a safe and workable agreement is reached.

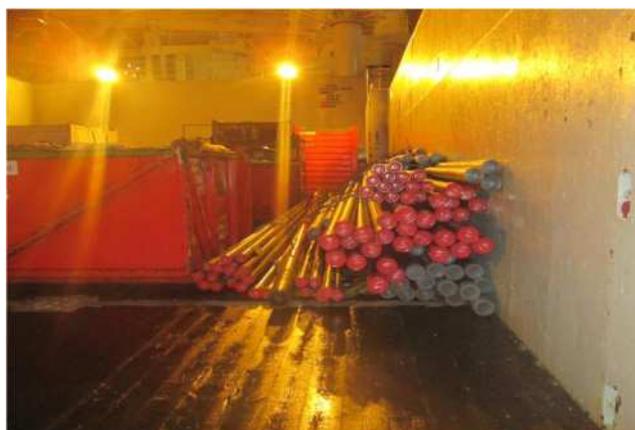
Incident No 3:

The vessel had been advised that a small amount of tubulars would be back loaded but the exact amount was not confirmed so no pipe pins were put in place, nor were bedding ropes or securing chains laid.

Once all the tubulars were back loaded they were blocked in using other items of back loaded cargo.

On return to port a safety concern was raised by stevedores due to concerns that lifting the restraining cargo would allow the pipe stow to move.

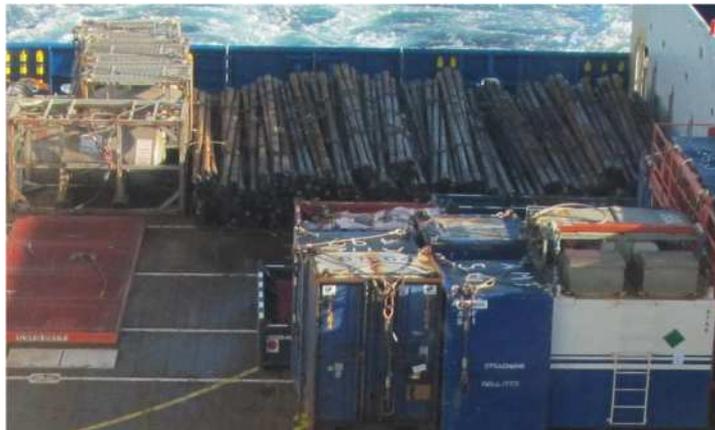
Incident No 4:

A PSV was working alongside an offshore installation carrying out cargo operations which included back loading a stow of tubulars. During the back loading of the tubulars several changes took place, the knock on effects of which were not fully appreciated or assessed by the vessel or the installation. These changes included:

- A change to the quantity of tubulars being back loaded. – Originally 40 bundles of tubulars were to be back loaded which would have comfortably fitted into the available space. This figure increased to 60+ bundles.
- A change in the weather – The vessel was originally sitting broadside to the installation but as the weather changed the vessel had to turn stern on thus reducing the reachable cargo deck area for the crane to back load into.
- A change in the type of cargo to be back loaded – There were several heavy lifts which also needed to be back loaded into the now reduced available space.
- A change in the securing arrangements – The pipe pins had not been installed and as the stow grew there was no way to secure the tubulars other than to use the heavy lifts to block the stow.

On return to port a safety concern was raised and the job was stopped until a safe means of discharge could be agreed.
