# Safety Alert

**Number: 16-12**

**Subject: Minor Fuel Spill During Offshore Transfer**

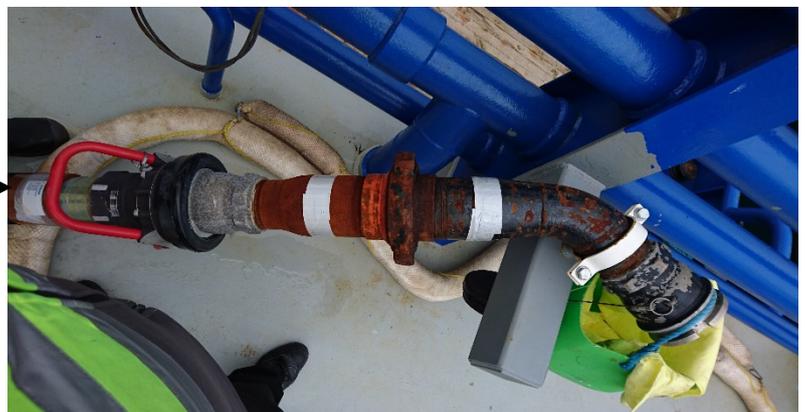
On this occasion the leak originated from the Port aft connection. This connection was not part of the vessels fixed pipework system, but a removable flexible hose connected to the port mid-ships manifold, leading aft to the port quarter. The hose was terminated with a dry break connection, which was capped at the time of the incident, the valve at the port mid-ships manifold was thought to be closed at the time of the incident.

For this spill to occur, the port mid-ships manifold valve and the dry-break connection had to be passing. After stopping the pumping operation, the ABs disconnected the flexible hose double checked the valve and replaced the cap on the mid-ships manifold. The fuel transfer was then completed without further incident.

Retro-fitted fuel line fed from the port mid-ships connection.

After this incident the flexible hose was removed and replaced with fixed pipework, the manifold valve inspected and the dry-break connection replaced.
