Safety Alert

Number: 17-08

Subject: Personnel Injury Whilst Using Pillar Drill

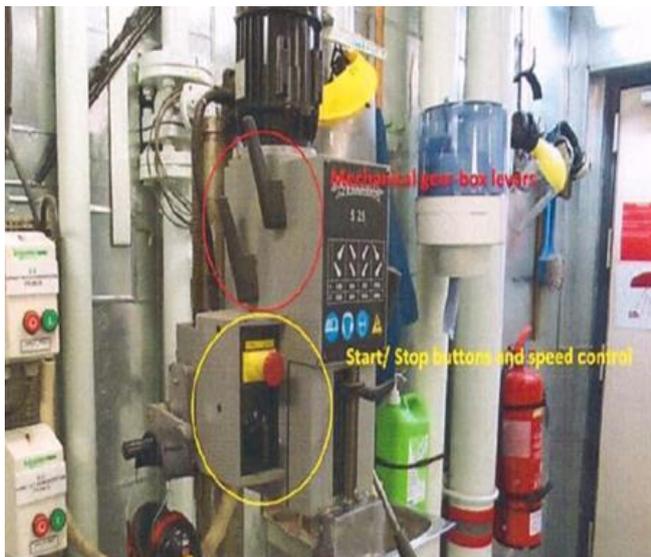
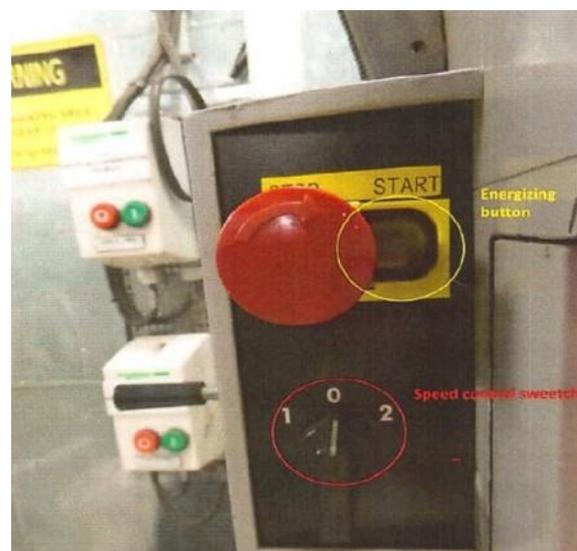
Photographs / Supporting Information

An experienced engineer was changing out a drill bit on a tower drill in the engine room workshop and while doing so he inadvertently operated the wrong handle and started the drill.

The engineer was wearing gloves to carry out this task and as the drill turned the glove caught and turned with the drill bit trapping his hand inside and causing a hand injury which then required shore side treatment.

- The drill had multi-function controls (including, clutch speed, gears, slow and fast operation, on/off switches) none of which were actually marked to indicate their purpose.
- By its design, the emergency stop button for the drill did not clearly identify to the operator when it was engaged or de-activated.
- There was no 'green light' (or similar indicator) to show when the equipment was 'energised'

The company introduced 'drill familiarisation' to the engineers induction and this was a positive step but it is also important that a full and comprehensive risk assessment is carried out for the use of all engine room equipment and that engineers intending to use the equipment are fully familiarised with the RA's and comply with its requirement.

Any equipment which has not been fully risk assessed should be quarantined until safety of the user can be assured.

NOTE: A more recent model of the same drill incorporates a safety feature where the drill cannot be operated if the drill guard is in the open position. This safety feature should be function checked to ensure it is fully operational before carrying out any drill changes.
