Safety Alert

Number: 17-10

Subject: Container Snagged by Installation Crane

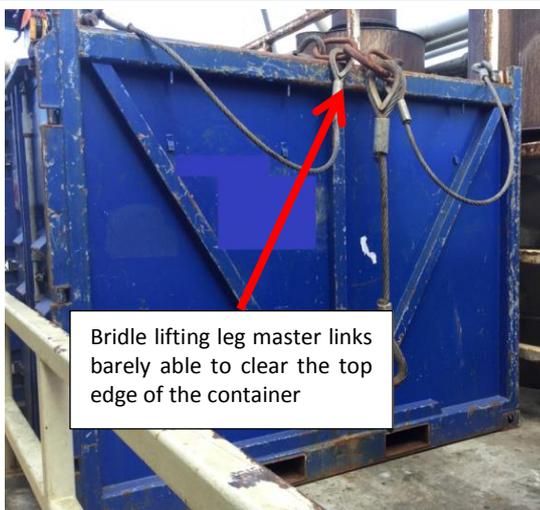
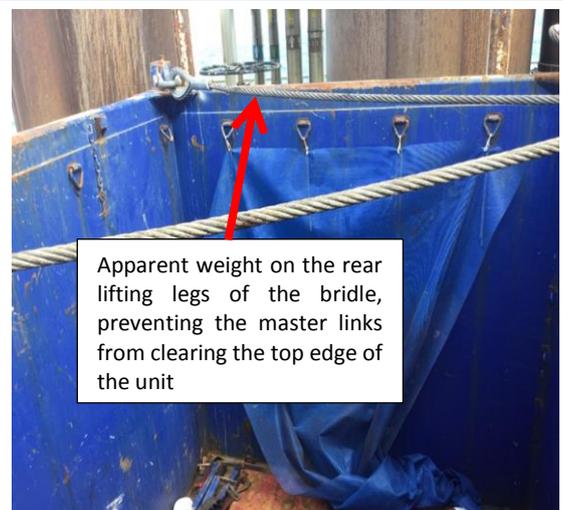
Photographs / Supporting Information

During cargo operations at an offshore drilling rig, a container was being raised up by the installation crane when it snagged the lifting bridle of an adjacent open top container, causing the lifting legs to slip back down inside. The vessel crew deemed it impossible to retrieve the lifting bridle from outside of the container and therefore decided to enter the unit in order to reach the bridle.

The legs of the lifting bridle on the open top container do not appear to have been sufficiently long enough to allow any slack, therefore when the bridle was snagged by the adjacent container there was sufficient weight on it to pull it down inside the container.

Another factor was the lack of a net or tarpaulin to prevent the bridle legs from slipping back inside the container.

- A safety briefing was held with the operator's representative to highlight their safety concerns and to emphasise the "Stop the Job" policy. All personnel were instructed that if the job cannot be done safely then it does not get done at all.
- The use of nets/tarpaulins on open top units should be considered, even when empty, to try and prevent similar incidents occurring in the future.
- Container lifting legs/bridles should be of a sufficient length to ensure that they hang over the side of the unit with enough slack to prevent them slipping back inside
