Safety Alert

Number: 18-13

Subject: Cargo Shifted on Deck - High Potential Near Miss

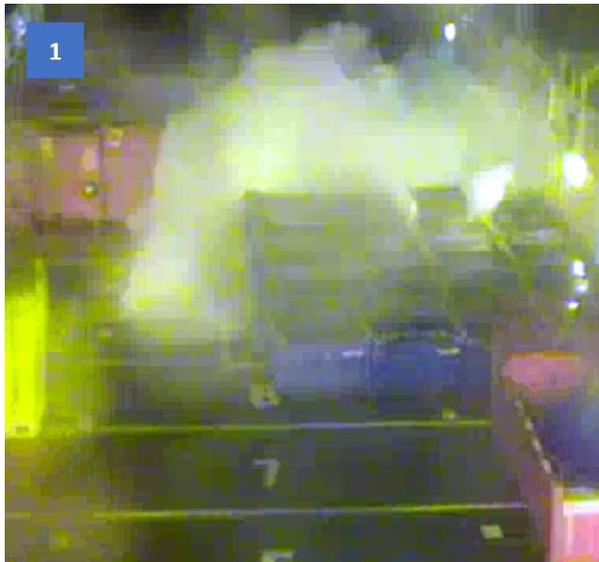
As the vessel was being manoeuvred towards the working position, a wave significantly larger than the forecast or of maximum wave height passed the vessel. The wave caused a significantly larger pitching motion, the stern of the vessel dropped into the trough behind the wave and subsequently dug into the face of the following wave causing the wave to break over the stern of the vessel (photo 1)

- The wave encountered was significantly larger than those experienced throughout the day or forecast.
- The vessels positioning in relation to the weather resulted in the part of the vessel offering least protection to the deck, being exposed to the weather.
- The deck cargo was unsecured at the time of shipping the wave.

- Cargo is to be secured at all times it is not being worked, regardless of weather conditions. This includes during periods of stand by and Waiting on Weather.
- Reporting of incidents to clients is to be completed in line with their stated requirements.
- DP set up time is to be conducted in line with client requirements or the system manufacturers manual, whichever is greater.

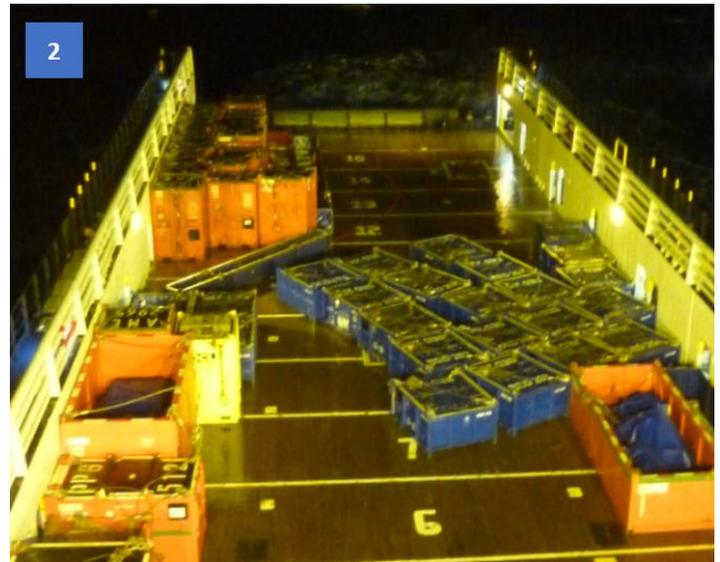
The water on deck caused a 24ft basket and 20 mud skips to be shifted across and up the deck. (photo 2)
