Safety Alert

Number: 18-15

Subject: Potential Dropped Object

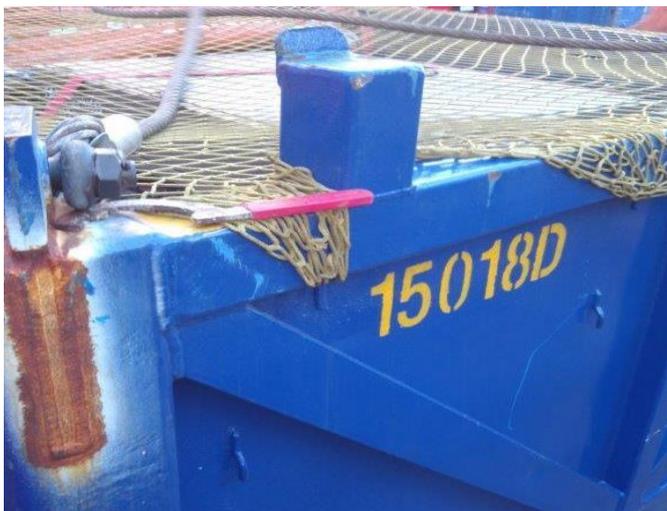
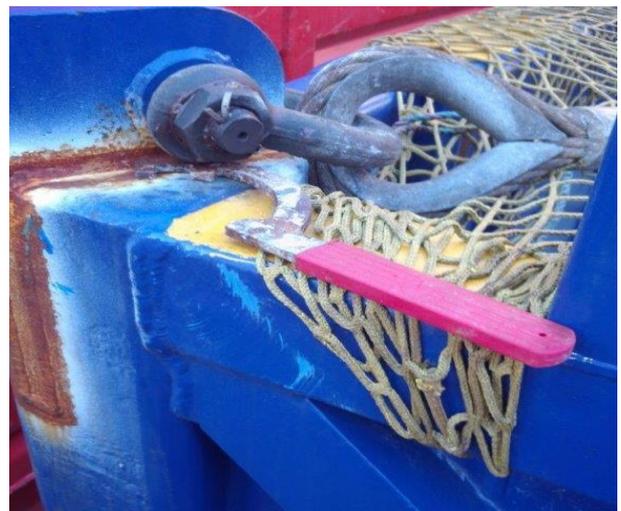
Photographs / Supporting Information

A lapse in attention by the individual using the tool and a failure in the post work inspection meant that the tool was left on the container on completion of the fire exercise the previous day.

The photographs show that this object was both conspicuous (red handle against blue coloured container) in appearance and left in a conspicuous position on the container. The procedural control measures in place should have easily resulted in discovery of the PDO before the container was discharged to the platform:

1. The risk assessment for the discharge of deck cargo operation notes the possible hazard of "Personal Injury or Fatality due to dropped objects from above" and one of the associated control measures as "Prior to connecting a container for discharge, the deck crew should inspect the lift for any loose items that may fall during transfer.
2. The company IMS requires that such risk assessments are the basis for pre- work briefings.

The industry overall has an ongoing issue with dropped objects. Vessel personnel, being those exposed to the highest risk, should be at the forefront of the effort to reduce such incidents. The need for a pre- lift check is always highlighted and must be fully adopted into the safety culture and re-iterated during documented tool box talks.
