Safety Alert

Number: 18-16

Subject: Machinery Failure

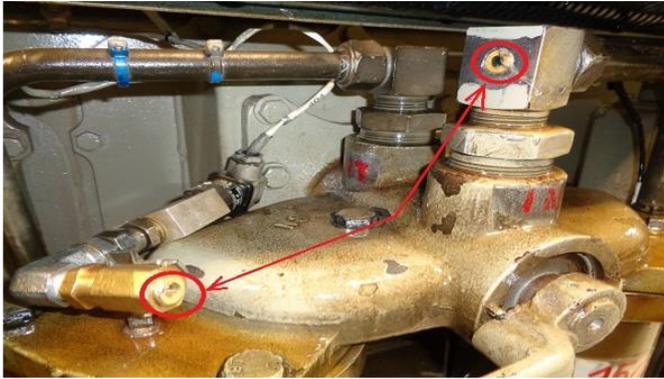
On inspection the fuel oil secondary filter differential pressure sensor isolating valve on the port main engine had cracked and was causing the fuel spray. It was estimated that approximately 1m³ of fuel had been lost to the bilges.

The failure of the valve was caused by a combination of engine vibrations and the weight of the assembly acting on the male threaded section of the brass valve.

The pipe arrangement had been altered from the original set up due to pressure fluctuations interfering with the proper functioning of the sensor. The long-term impact of the alteration does not appear to have been properly assessed by the manufacturer prior to the alteration being made

Failed connection as found by duty engineer

- The brass valve fitting is to be replaced with a stainless-steel equivalent to provide additional strength to the arrangement.
- A deflector plate was added above the valve in order that in the event of any future failure, any fuel spray will be prevented from contacting hot parts of the engine.
- Support arrangements for the assembly were investigated but deemed impractical.

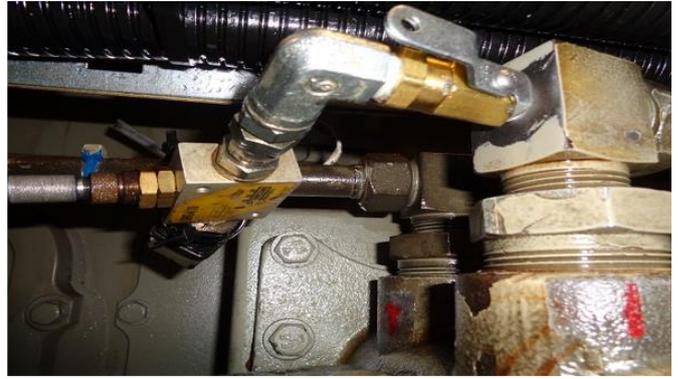
Connection after initial temporary repair

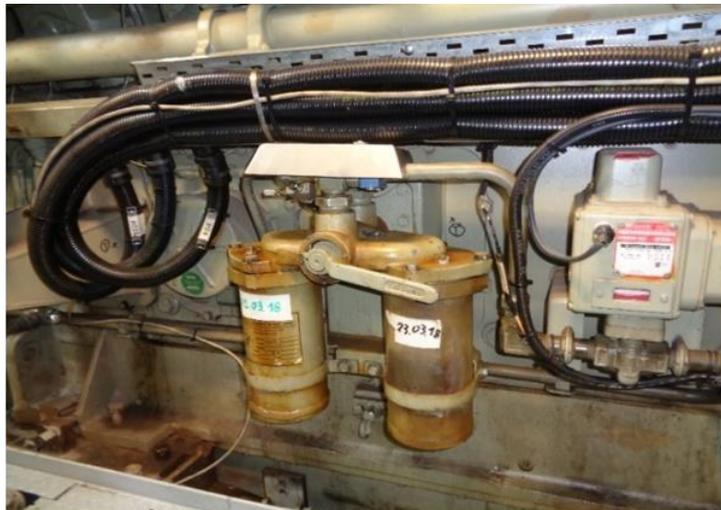
Deflector plate fitted to prevent fuel being sprayed onto the hot areas of the engine
