# Safety Alert

**Number: 18-19**

**Published: 27/07/2018**

**Subject: Snagged Lift**

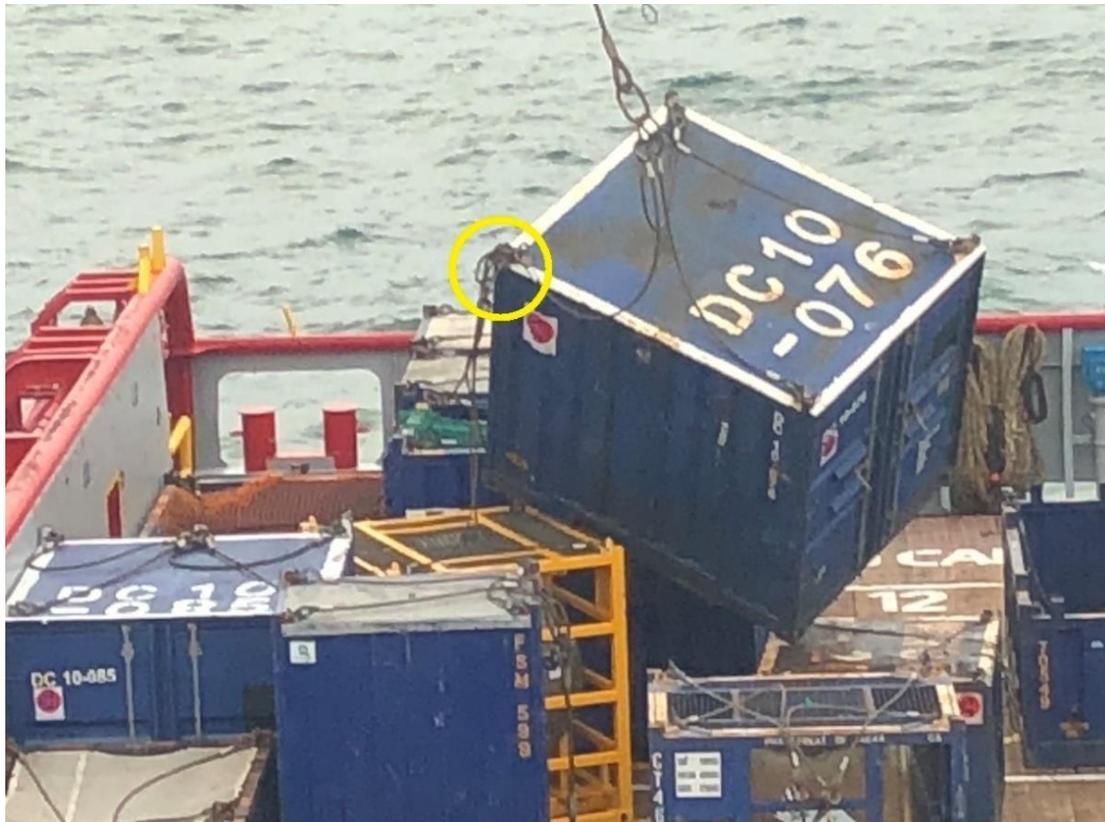
During deck cargo operations at an offshore location, a hoisted 10ft container became snagged on the bridle of a backloaded tote tank. A 'Stop Stop Stop' was given over the Radio and the Crane Operator immediately stopped hoisting and both containers remained suspended 3m off the deck. The Crane Op tried unsuccessfully to manoeuvre both containers free but due to restricted space on the deck he was forced to land the containers on top of a nearby tubular stack.

- The usable deck space was fully utilised with limited space to manoeuvre and stow cargo.
- The number of lifts declared for offload and backload altered significantly while the vessel was on location, including additional tubulars to be backloaded.
- The snagged bridle could not be seen from deck level by the crew or from above by the Bridge Team and Crane Op.
- Each corner of the 10ft container was fitted with a guiding pin which stopped the snagged bridle slipping free as the weight came on.
- The snagged bridle was not 'tucked away' or secured when the tank was backloaded.

When safe to do so, the vessels deck crew approached the lift and removed the bridle using a long boat hook. The containers were safely discharged and deck items securely re-stowed with minor cosmetic damage to the tote tank.

- The bridle of the tote tank could have been tucked away into the grillage after disconnecting the hook. These actions would not have prevented this incident but may help prevent future similar incidents before they occur.
