# Safety Alert

**Number: 18-23**

**Published: 26/10/2018**

**Subject: Near Miss – Potential Dropped Object**

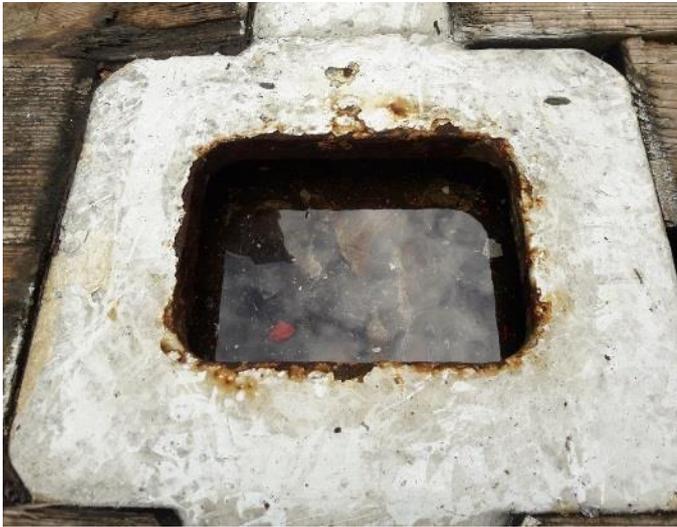
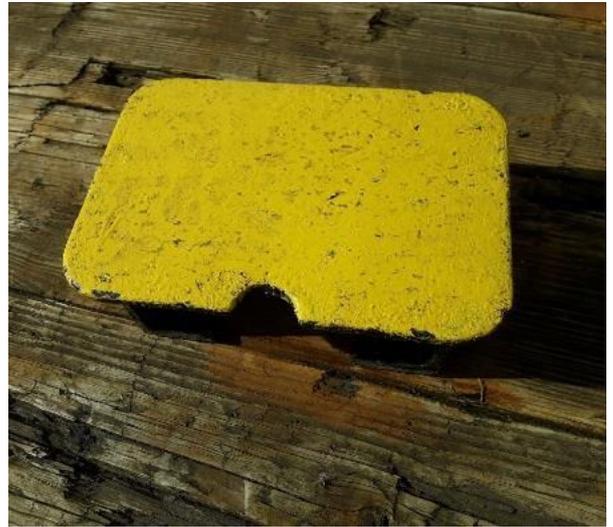
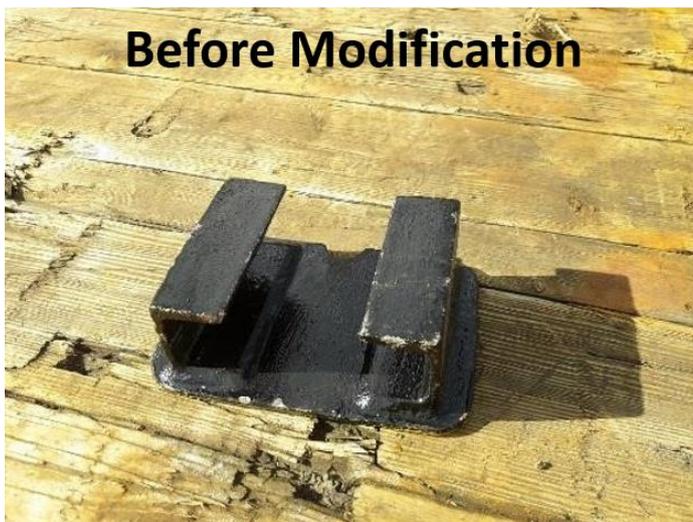
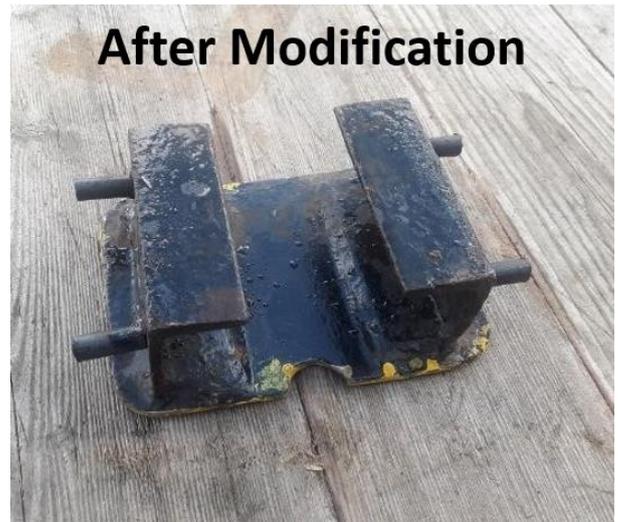
During cargo operations at an offshore location, a 20ft basket was discharged from aft on the main deck. Shortly afterwards bridge team were informed by the installation crew that a yellow metal plate was found trapped inside the forklift pocket of the basket. Later that day, a picture of the plate was sent to the vessel and ships staff confirmed that the plate originated from the vessel's deck.

The plate in question was used to protect a potential trip hazard (stanchion mounting holes) when not in use.

Note that the control measures listed did not include pre-inspection of the deck. The control measure requiring a pre-inspection of the container alone failed, as it did not identify the potential dropped object. However, it should be noted that the ability to conduct a full inspection of a container prior to lifting from a vessel's deck can be impaired and may not always identify all Potential Dropped Objects, e.g.

A spare cover plate was immediately fitted, and the trip hazard removed. Ship Staff were also able to engineer a solution so that no single motion i.e. wave action on deck could result in the plate being inadvertently shifted. Additional pins have been added which will hold the plate in place unless intentionally removed.
