Safety Alert

Number: 18-24

Subject: LTI – Squeezed Thumb

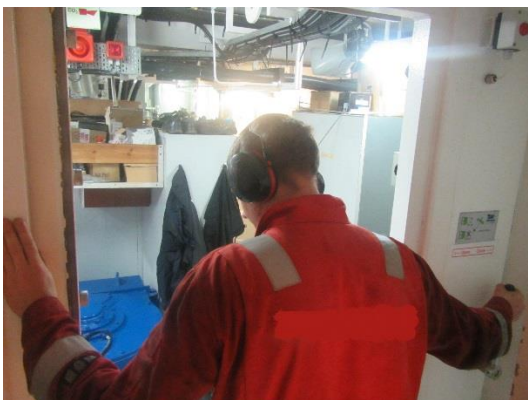
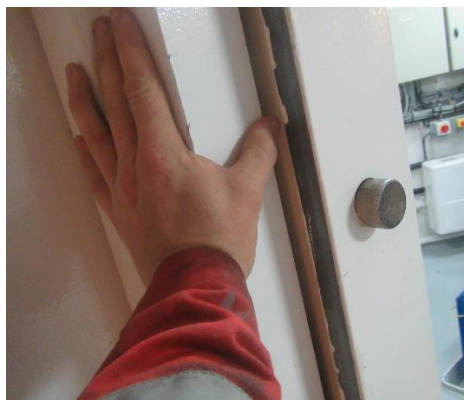
The Injured Party was opening the watertight door into the bow thruster room at the end of his shift. As he placed his hand on the operating handle, he placed his other hand on the watertight door framework opposite. As the door opened it squeezed his thumb in between the frame plating and the door housing.

The Injured Party placed his hand on the opposite side to steady himself just in case of movement by the vessel. Unfortunately, the framework provides a flat surface and is easily taken as being a “safe spot” to place hands while operating the operating lever.
