# Marine Safety Forum – Safety Flash 15-13

Issued: 27<sup>th</sup> April 2015

Subject: Hose Incident

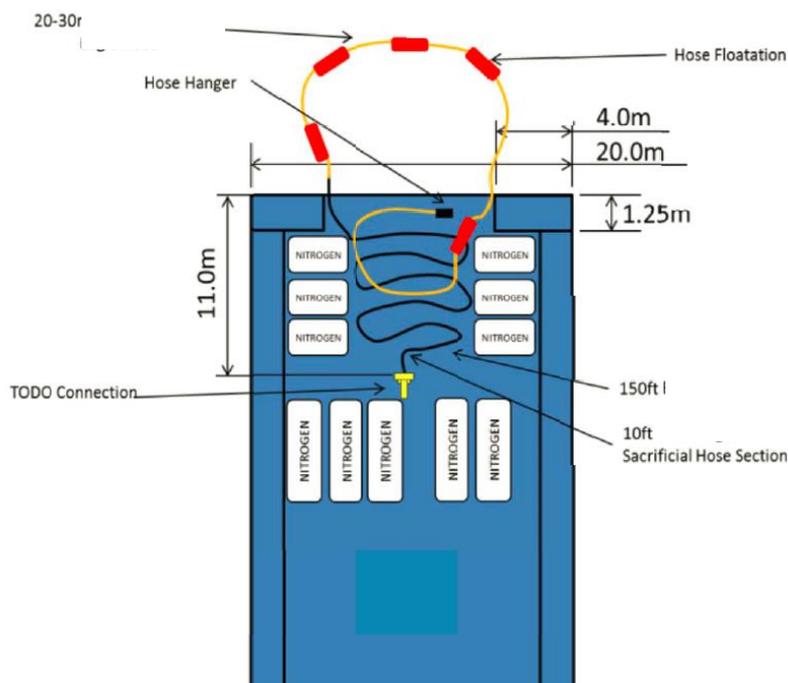
Fig: Deck layout and hose position

The incident involved a 2" bulk chemical transfer hose that had been passed up to the platform, and was being passed down to the vessel.

- 337ft (102m) of bulk transfer hose including fittings being pulled into the port azipod of the vessel
- Irreplaceable damage to the bulk hose
- Delays to operations
