Marine Safety Forum – Safety Flash 15-16

Issued: 4th May 2015

Subject: Fatal incident during change-out of chain wheel (gypsy) on AHTS vessel

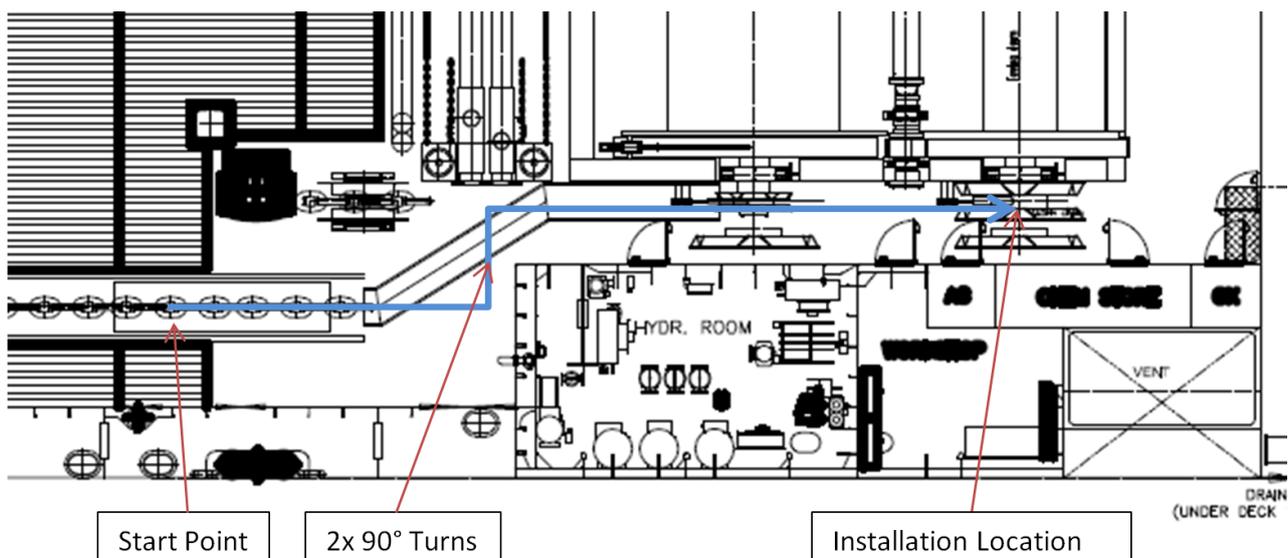
Plan view drawing of the intended route for the installation of the gypsy

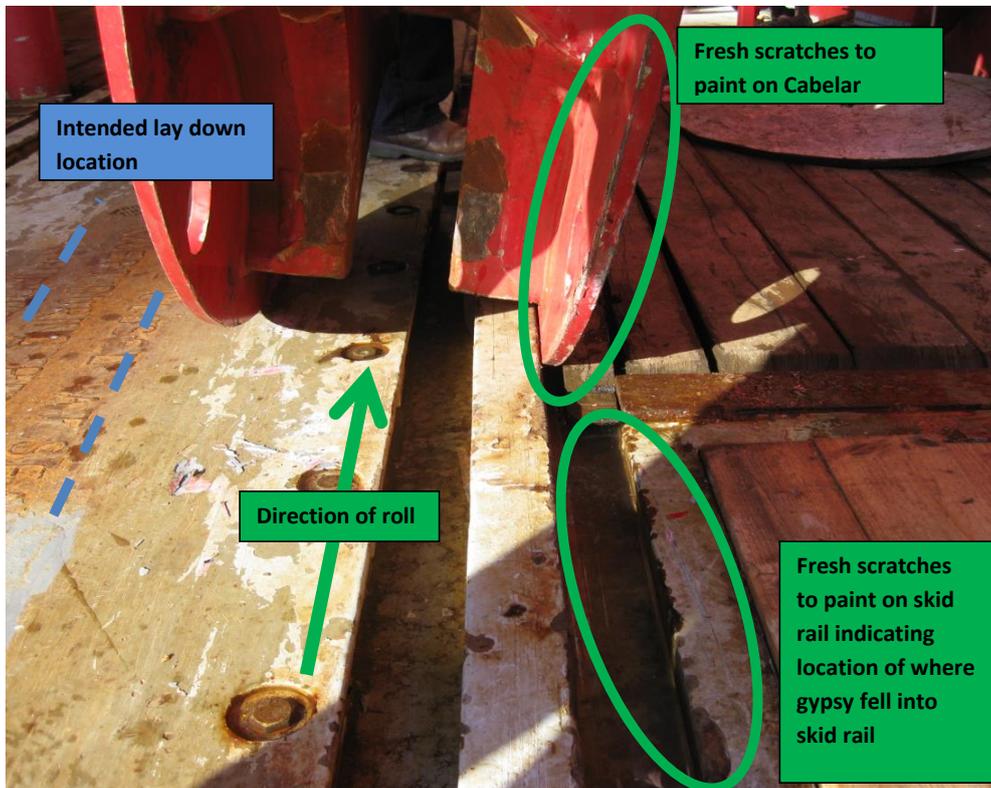
The crew disconnected the gypsy from the crane without checking its final landing position. Therefore, they did not see that the rims of the gypsy wheel were on each side of the skid rail for the chain lifter. Immediately after disconnecting from the crane, the crew started to roll the gypsy. This resulted in the starboard rim dropping into the gap in the rail causing the wheel to tip beyond balancing point. It fell over and pinned two crew members against the bulkhead. This resulted in one fatality and one first aid case.

Showing the cause of the gypsy wheel tipping over (the term “cabelar” is used as well as “gypsy”)

- ◆ The immediate causes were:
 - Gypsy rolled into skid rail causing it to tip over;
 - Lack of risk management;
 1. Failure to identify hazards and risk.
 2. Failure to comply with safe working practices.
- ◆ Contributing factors:
 - Inadequate design review for this particular mode of operation conducted by vessel;
 - Gypsy was not handled in the intended method as established when vessel was designed;
 - Insufficient lifting or handling appliances for handling and changing the gypsies.
- ◆ Root Causes:
 - Inadequate monitoring and verification of organisational performance;
 - Weaknesses identified in the design review processes;
 - Lack of effective implementation of risk management.

- ◆ Company-wide instruction forbidding free-rolling of these heavy items;
- ◆ Technical task force to evaluate a safe method for the installation of gypsies in the short and long term and review change- out methods across the fleet;
- ◆ All vessels to review and re-risk assess current methods for handling gypsies and submit risk assessment for approval.
