Marine Safety Forum – Safety Flash 15-17

Issued: 4th May 2015

Subject: Tag Line Incident

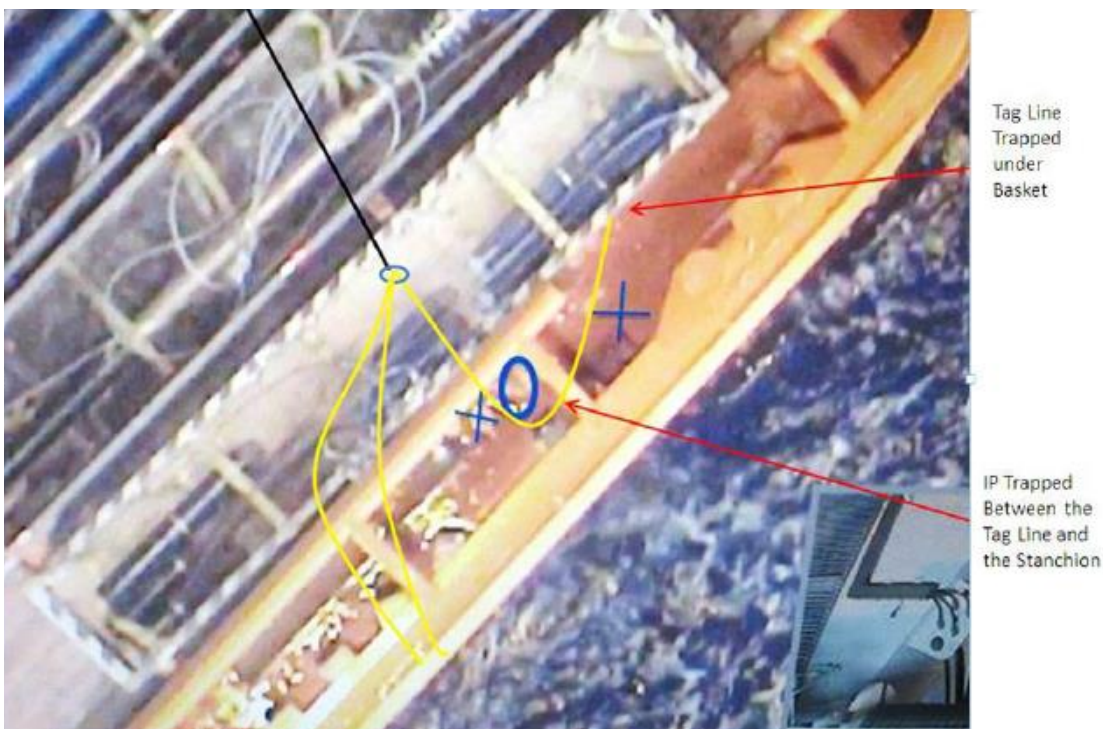
Photograph 1 – Location of Trapped Tag Line

Photograph 1 below shows the tag line (yellow line) routed around the stanchion and the banksman attached to the crane hook (blue circle).

The banksman signaled by radio for the crane operator to hoist up the hook and tag lines. As the crane hoisted the hook, the trapped tag line became tight pinning the banksman against the stanchion with the tag line.

- Review procedures with customer and vessel operator to address appropriate use of tag lines including use of risk assessment for when to use or not to use tag lines. (review of WRA between vessel and rig before loading/unloading operations commence)
- Vessel operator to address this incident with their staff for proper banksman duties
- Rig personnel to review this incident (in particular crane operators) and communicate with vessel supervision when vessel crews are not following correct procedure
- Use of ‘Time Out for Safety’ as appropriate

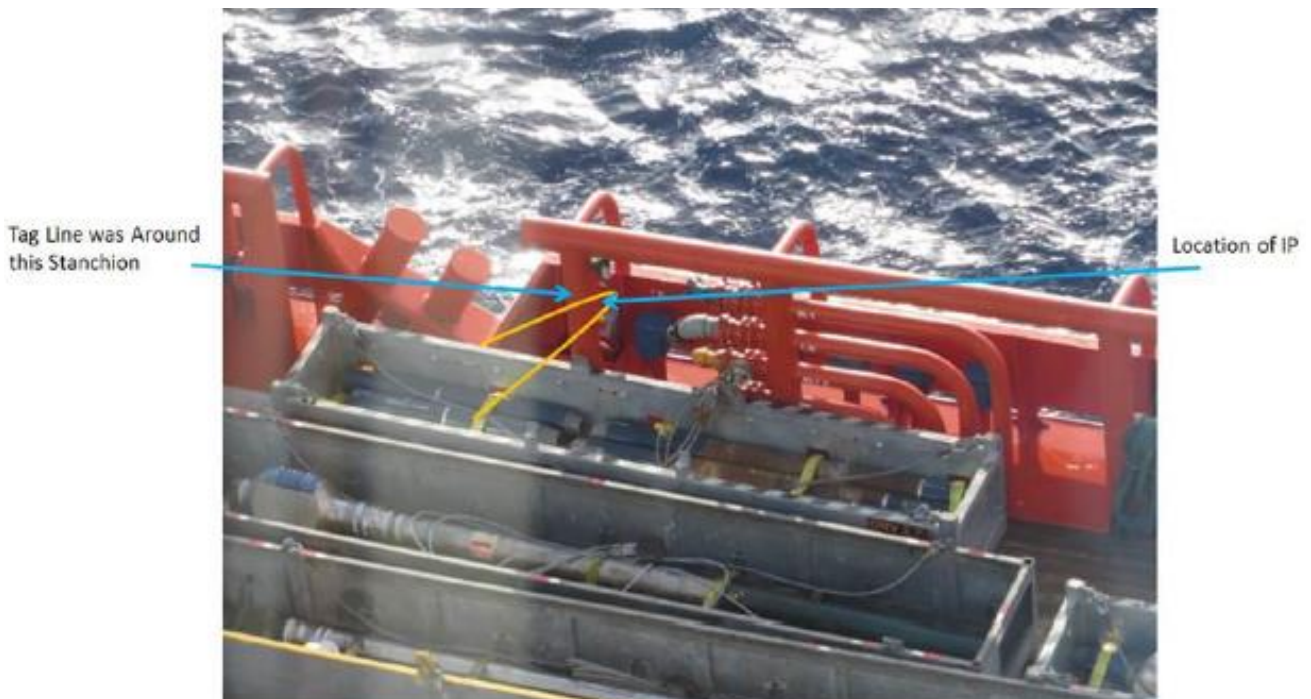
Photograph 2 – View of Basket and IP Location

- Inadequate supervision and oversight by vessel banksman; did not follow job duties and stay well clear of “any” lift (includes all personnel)
- Inexperience of sling men on vessel (relatively new personnel)
- Failure to recognize the hazard
