Marine Safety Forum – Safety Flash 15-20

Issued: 29th June 2015

Subject: Lithium Battery Contents in Eyes

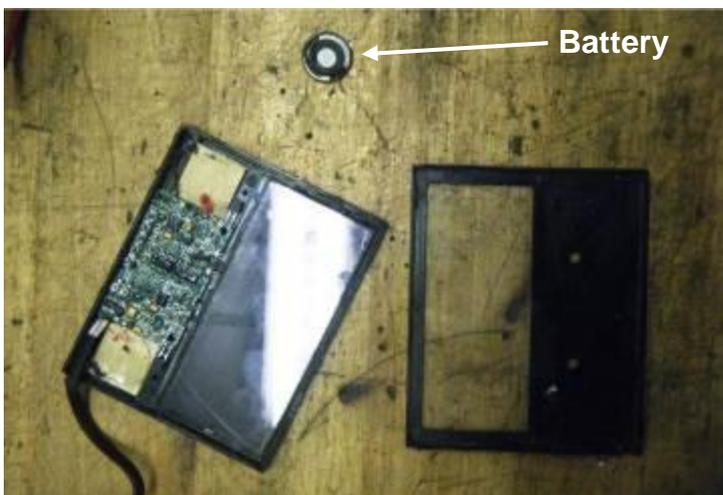
Fig.1 Lithium Ion Battery

- Failure to use PPE - The lack of guards or barriers was due to the task being thought of as a low risk, everyday work so no formal R/A was undertaken. The small tablet size battery (see fig.1) appeared to be inconsequential as a hazard. Soldering connections onto batteries is not a rare event for an electrician. The original battery connections were soldered on via machine during manufacturing. The precise nature of the work drew the ETO's concentration and he neglected to wear effective PPE (Safety glasses or mask) to undertake the repair.

- Inadequate time was allowed between soldering operations for the battery to cool down causing it to over pressurise and fail resulting in the injury.

- Requirement to undertake adequate Risk Assessment – The importance of adequately assessing risk needs to be emphasized. Though this task appeared innocuous it could have resulted in a more serious injury. Master has since called an extra safety meeting to discuss the accident with crew.
- Adequate PPE to mitigate against potential injury – All risks to be assessed and correct PPE for task to be worn.
- If the IP had carried out the Risk Assessment he would have most likely recognised and addressed the hazard.
- The Master used the Sat B Service Address Calls quick dial 32# for advice regards the accident on board. There are other services available but the Inmarsat one is tailored specifically for seafarers (Is free) and have contacts to cope with a multitude of situations.
