# Marine Safety Forum – Safety Flash 15-22

**Issued: 09.07.2015**

**Subject: Vent Pipe Clogged**

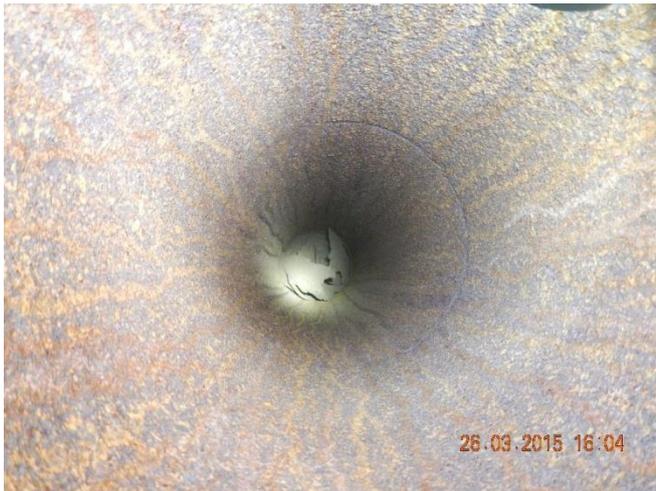
To further investigate, the complete vent head was removed and a blockage was observed in the vent pipe at the first elbow, approximately 1.5 meters below the deck level. It consisted of large rust scales and hardened dust. (Please see photographs below). Due to this discovery, FO tank #2 was inspected and found to be in a similar, although to a lesser extent, condition.

The capacity of FO transfer pump is 2 x 50 m<sup>3</sup>/hr, which is significant considering the size of the tank. However with the amount of vacuum it created, it is obvious that the vent pipe was blocked and there was no air relief at all.

This incident could of easily lead to serious damages to the FO tank / hull construction if it had not been discovered.

- The collected rust and scale was removed.
- The vent pipe has had an internal inspection job created and included in her Planned Maintenance System.

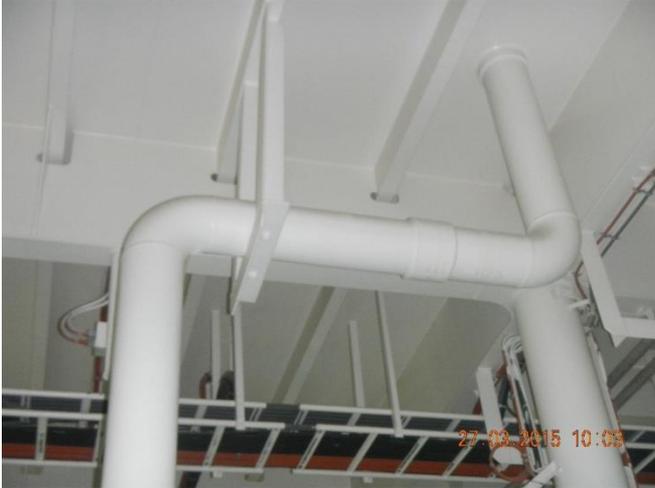
The design of the vent had sections that were vertical, horizontal, and then another near vertical. See photo.

- It had not been recognised that, although the exterior of the pipe was in good condition, there would also be a necessity to open and inspect the inside of the pipe. That was not done.
- . Over several years, rust and scale had accumulated in the vertical section, the rust and scale had then collected at the foot of the upper vertical section, as it did not have any slope to help take it away [admittedly into a FO tank, but where it would likely sit at the bottom of the tank].
