# Safety Alert

**Number: 16-15**

**Subject: 'Stop the Job' Your Responsibility**

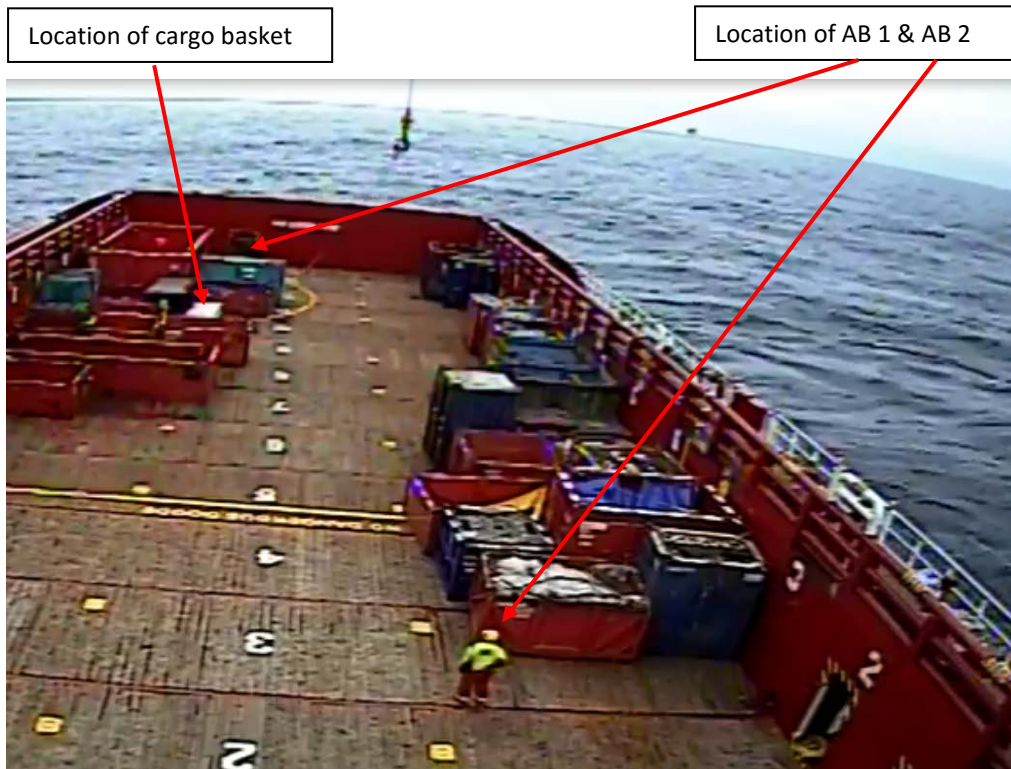
After unhooking the previous back loaded CCU the AB's 'walked the crane' approximately 15 metres and hooked on a cargo basket, they then left the area and the crane began to take the strain. As the slack was being taken up the lifting bridle caught under the lid of the basket, fortunately the crane driver noticed the lifting bridle snagging and lowered the load, unfortunately both AB's had walked away from the basket in different directions neither observing the basket being lifted and so neither were aware that the lifting bridle had snagged, nor could they see each other to highlight the problem.

- The vessel has since undertaken a full review of their cargo handling procedures including:
  1. A time out for safety meeting to discuss the incident

2. A review of their cargo operations procedures and risk assessment
  3. A revision of their cargo operations toolbox talk to include items such as enforcing 'stop the job', working together as a team, good communications with the installation and avoiding 'walking the crane'

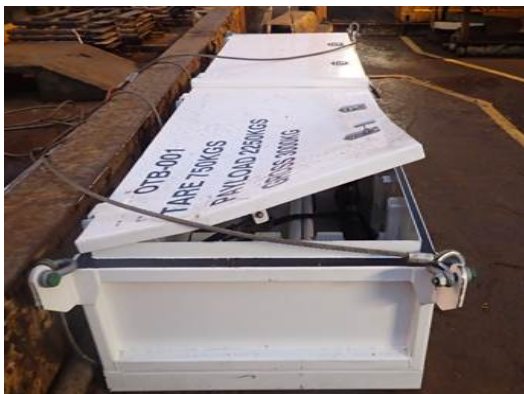
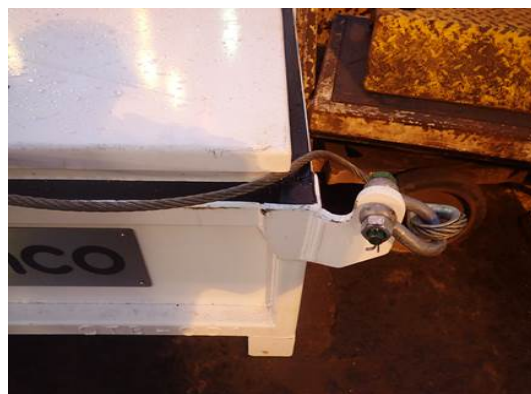
After a short time both AB's made their way back to the basket and cleared the lifting bridles. They then stood clear in a safe haven nearby while the crane took up the slack but once again the lifting bridle caught on the lid, this time buckling the lid exposing the cargo inside.
