Safety Alert

Number: 16-20

Subject: Pallet Strop Hook Broke and Hit AB

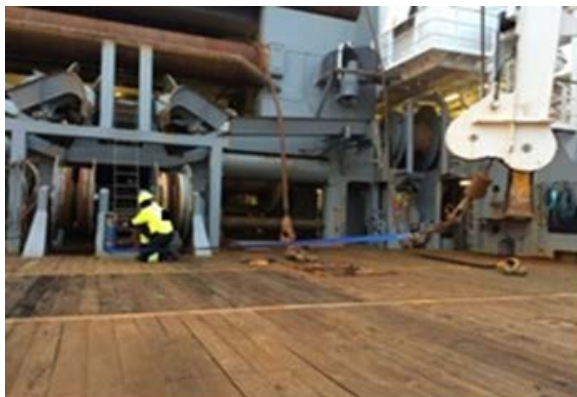
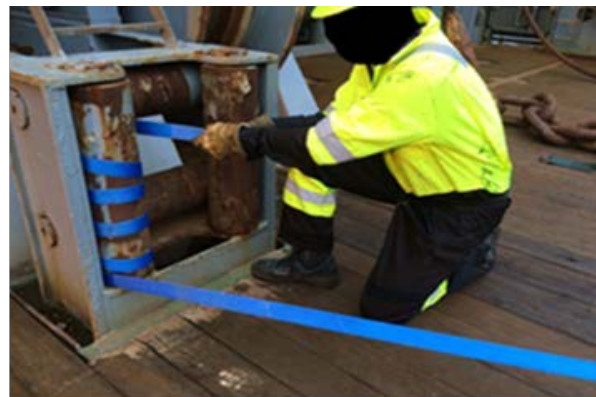
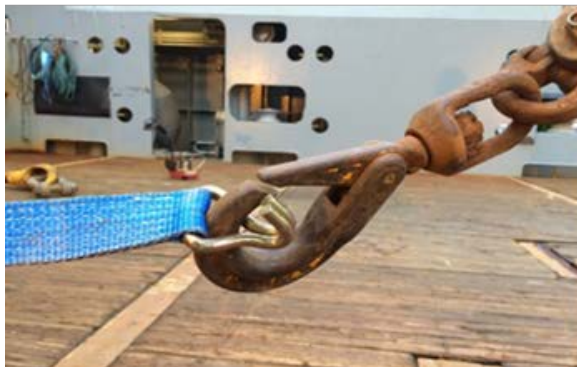
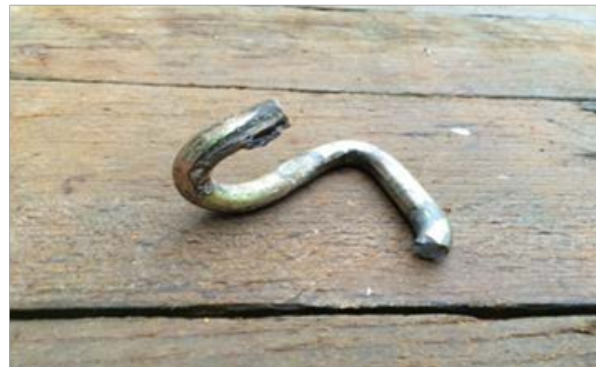
Photographs / Supporting Information

During maintenance on deck the vessels AB's discovered a roller on a winch that was stuck. They decided to try to loosen it by the use of the rail crane fitted on the vessel. When the crane driver tried to pull it lose the pallet strap hook broke off the crane hook and hitting the AB in the back. The AB was severely injured.

The pallet strop hook was incorrectly secured to the crane hook making it much weaker than the limits of the lifting strops SWL

1. Incorrect use of tool/equipment
2. Personnel standing in snapback zone
3. Lack of Planning and Risk Assessing Task

1. Proper planning and risk assessment of all work tasks to ensure safe operation
2. Ensure correct tool is used for the task
