# Safety Alert

**Number: 17-01**

**Subject: Tugger Winch Incident**

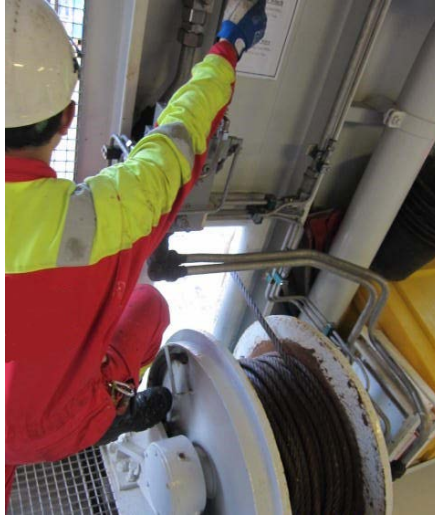
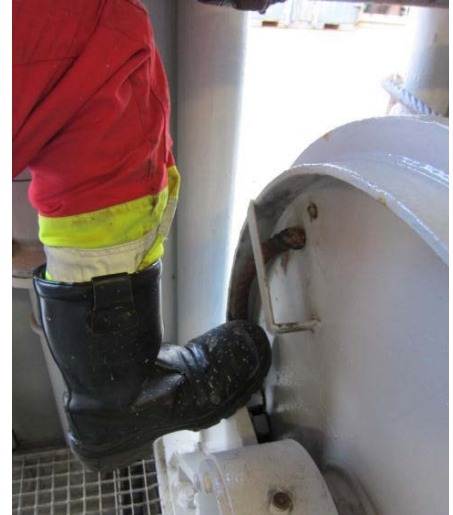
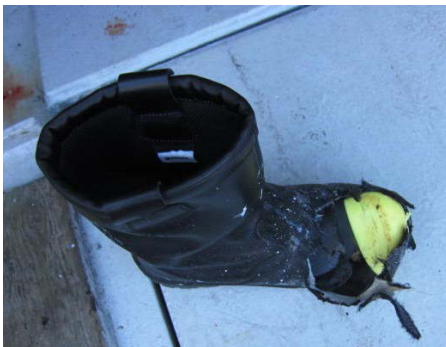
The AB stood at the tugger winch with his right foot resting on the winch support plate and started heaving up the wire using the control handle which was located above the winch.

As the winch barrel rotated the wire securing bar trapped the AB's foot between the winch support plate and the rotating barrel crushing his foot as it rotated.

Following the incident, a protective frame was built around the tugger winch to prevent a similar incident from happening again.
