# Safety Alert

**Number:** 17-12

**Subject:** Dropped Object Whilst Re-Positioning Cargo

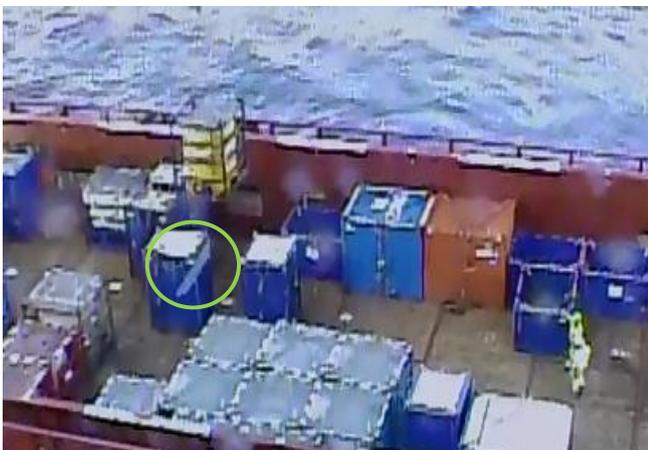
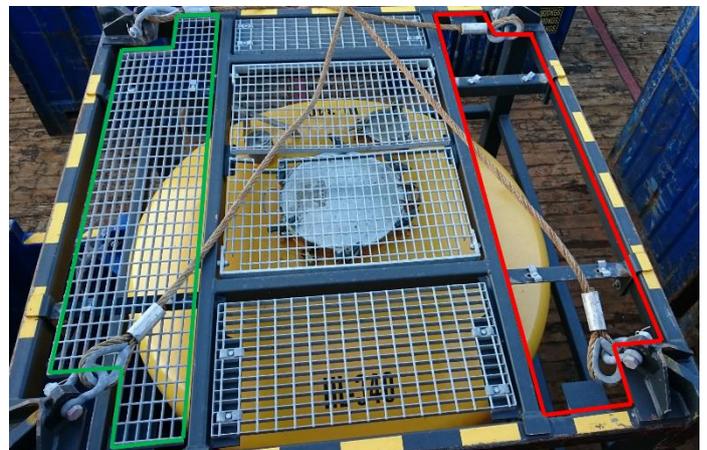
## Photographs / Supporting Information

At the request of the vessel Master, the rigs starboard crane was asked to re-position a tank on the aft deck of the vessel so it could be secured more effectively prior to the vessels departure for port. Whilst manoeuvring the lift, a piece of grating from the top of the tank was seen to fall from a height of approximately 6 or 7 metres onto the vessel's deck. The 2 deck crew were around 15 metres forward from the Dropped Object which weighed 17 kilograms. The incident has high potential but no injuries to personnel or environmental impact ensued.

The tank frame has grating sections on the top of the unit to cater for personnel accessing the hatch on the top of the steel tank. The centre sections hinge to allow the hatch on the top of the tank to be opened. The outer sections of the grating are intended to be fixed in place with four each bolts and butterfly clips. Whilst repositioning the lift the bottom of the tank made contact with the cargo rail tilting/rocking the lift causing the grating to fall off. On subsequent investigation in port it was found that only one clip was correctly fitted on one side grating and all four clips appeared slack on the side the grating fell from. One of the clips was also bent.

The unit was returned to port and quarantined until it could be lifted safely and returned to the vendor. A replacement tank was ordered and instructions given to the vendor to ensure checks are made to the securing arrangements on all their cargo units.
