Safety Alert

Number: 18-17

Subject: Strop & Pin Snagging During Hose Handling Operations

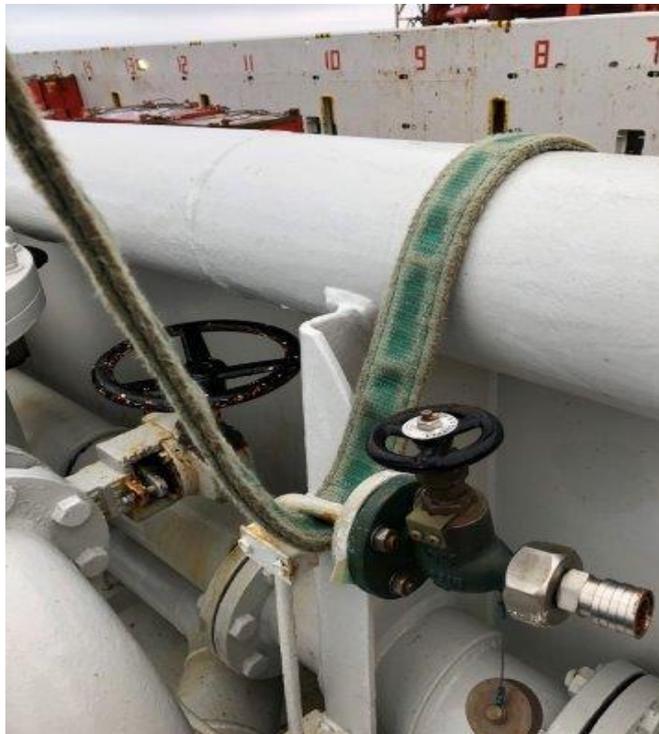
This method has been utilised successfully now for many years without incident however, recently while returning the bulk hose from the vessel to the installation the hang off strop lifted from the pin as per design intent but then caught up on a nearby air valve damaging the strop, the hose and the air valve.

Photo 1; Simulation of the hang-off strop caught around the air valve

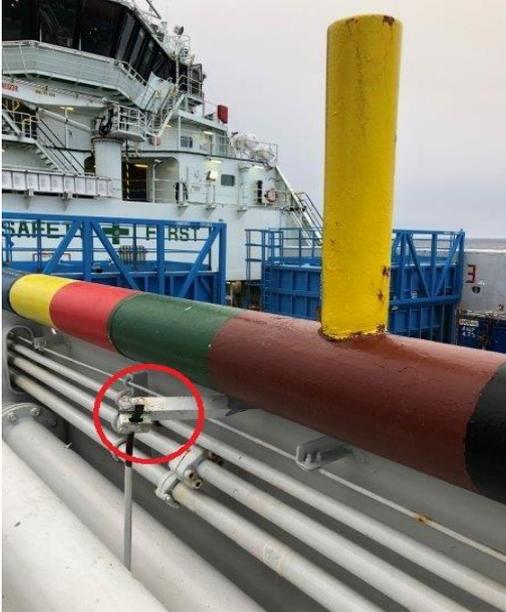
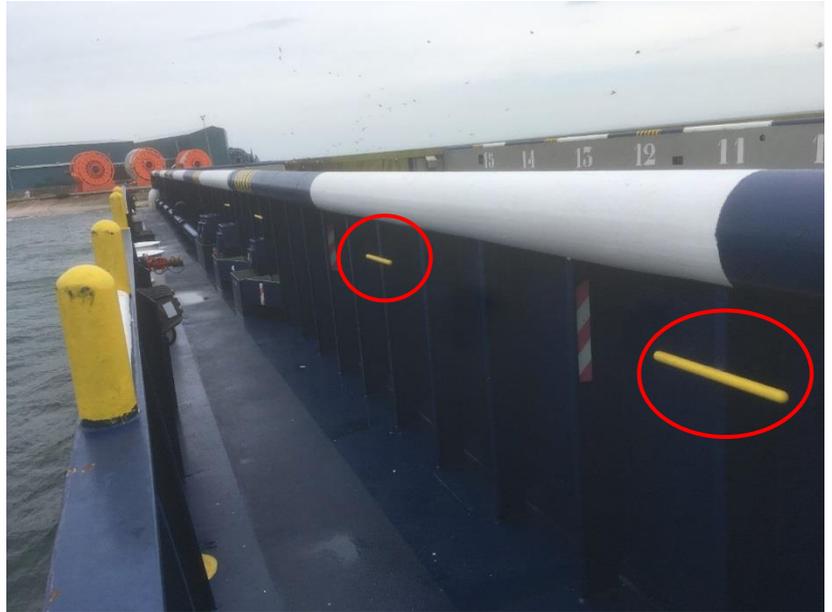
Subsequent checks on other PSV's have highlighted similar potential snagging points where the same incident could happen again.

Photos 2 & 3; Additional snag hazards identified on other vessels

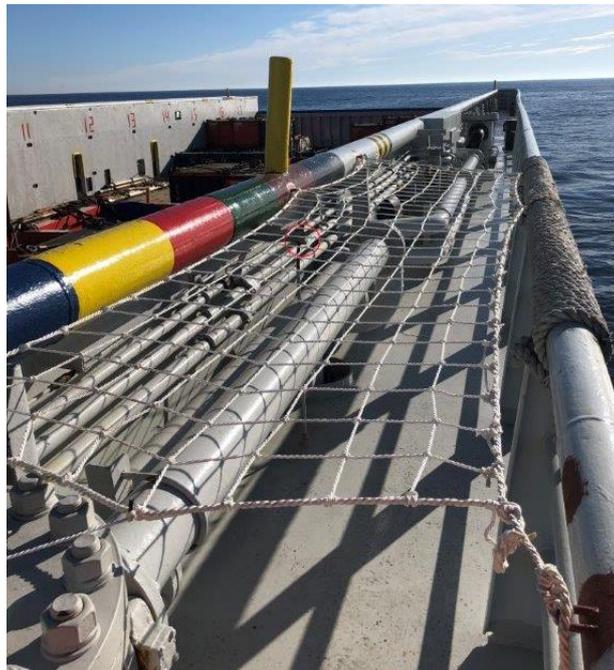
Photo 4; Protective netting in place

Having recognised the potential for this freak accident to reoccur one vessel crew have since put preventative measures in place by attaching netting as shown in the photo 4 below.
