Safety Alert

Number: 18-25

Subject: Anchor Brake Failure

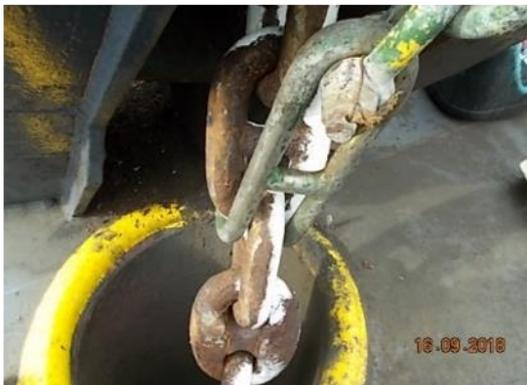
01 – Claw as Intended

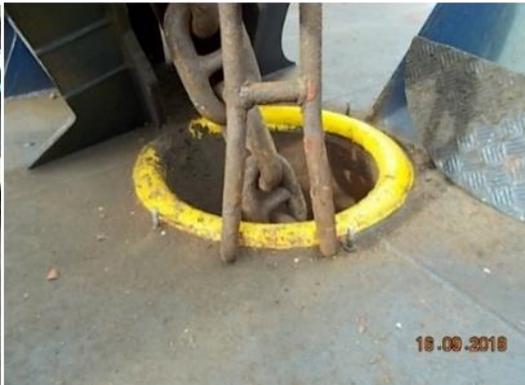
The devils claw had been engaged on the anchor cable and tightened leaving no gap or slack in the lashing. The two arms of the claw opened as the weight came on them, allowing the cable to pass through. No significant corrosion was noted on the equipment that would have materially altered its strength.

02 – Claw; post incident

- Any seized or non-operational parts to be freed up at first opportunity.
- Devils claws of the design shown are to be replaced with wire strops of appropriate SWL. Any alternative design are to be reviewed by vessel, with on shore assistance if required, and their continued use re-evaluated.

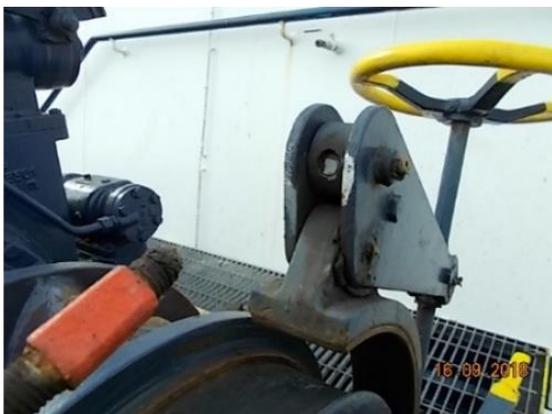
At the point of tightening the brake, the threaded spindle sheared, completely releasing the brake band. The full weight of the anchor was taken up by the devils' claw. The weight of the anchor coming on the claw forced the arms of the claw open, allowing the chain to run freely and the anchor and chain to run out to the dock bottom unrestricted.

On stripping the brake assembly for investigation of the failure it was found that both linkages housing the failed threaded spindle were seized. The lack of rotation in the linkages caused a bending force to be applied to the spindle when the brake was tightened. Over time this has caused stress within the spindle, and eventually complete failure.

The maintenance on the windlass and associated parts was conducted in line with the requirements of the planned maintenance system. All parts of the windlass were greased regularly, however, as has been identified in other mechanical failures, grease from the greasing nipples has not penetrated every part of the equipment. This has led to the linkages becoming seized.

03a – Failed section of brake assembly

- All vessels to conduct thorough inspection of moving parts of the anchor windlass with particular focus given to the brake band assembly. All moving parts are to be confirmed operational.

- Routine greasing must be carried out to ensure all parts are properly lubricated. When greasing, moving parts are to be moved to full extent of operation to ensure they are still functional.

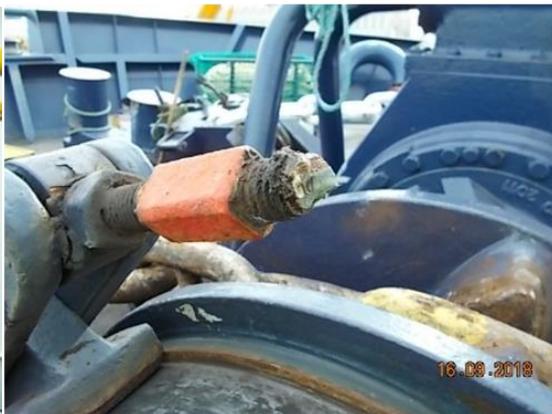
03b – Failed section of brake assembly

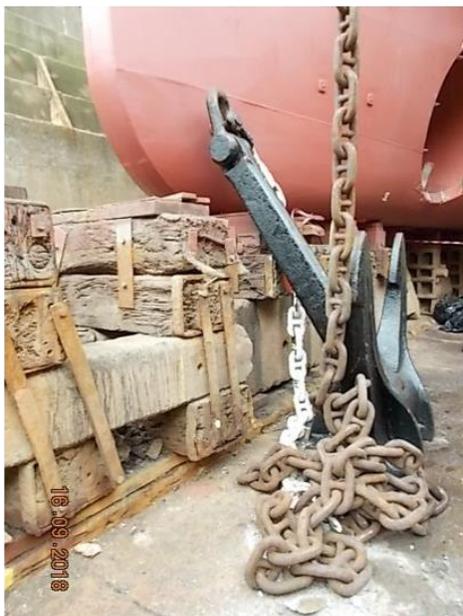
04 – Anchor; post incident

- All anchoring operations must include a check of the area to ensure no other party is placed at risk by the job, i.e. overside check for small craft at sea or in port, and exclusion zone in the proximity of the anchor during dry dock.
