## Marine Safety Forum – Safety Flash 15-01

**Subject: Dropped Object**

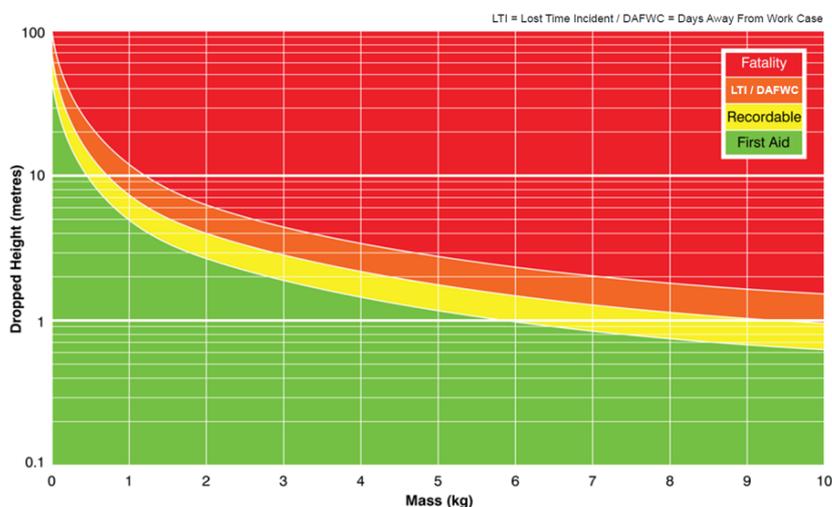
**Estimating the wood weighs 3-4kg, the dropped object calculator shows that the consequences of the wood hitting someone from that height could be potentially fatal.**

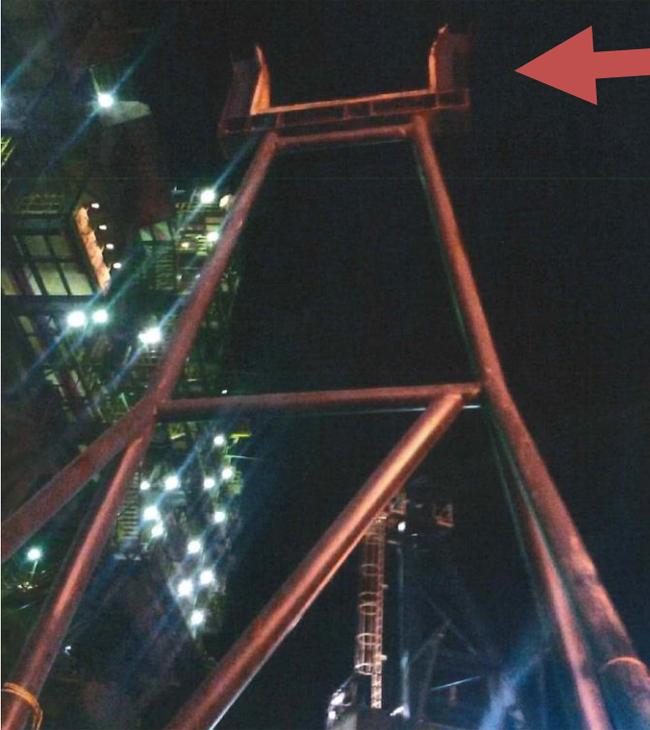
After an initial inspection, it was discovered that the dropped object was not a loose item that had been displaced but was in fact a section of the jib stowage arrangement, which had apparently split and come lose from the jib support arrangement.

**Original location of wooden support**

The vessel has completed a full and thorough HSE inspection of all deck areas to check for other weak points and also to ensure there are no loose/unsecured items which could fall onto decks or spaces below. This location has been 'barriered off' at deck level in case any other sections have become weakened and all personnel on board have been reminded to maintain vigilance to the possibility of dropped objects

A full inspection and review of the crane securing arrangements has been completed and no further loose items were found.

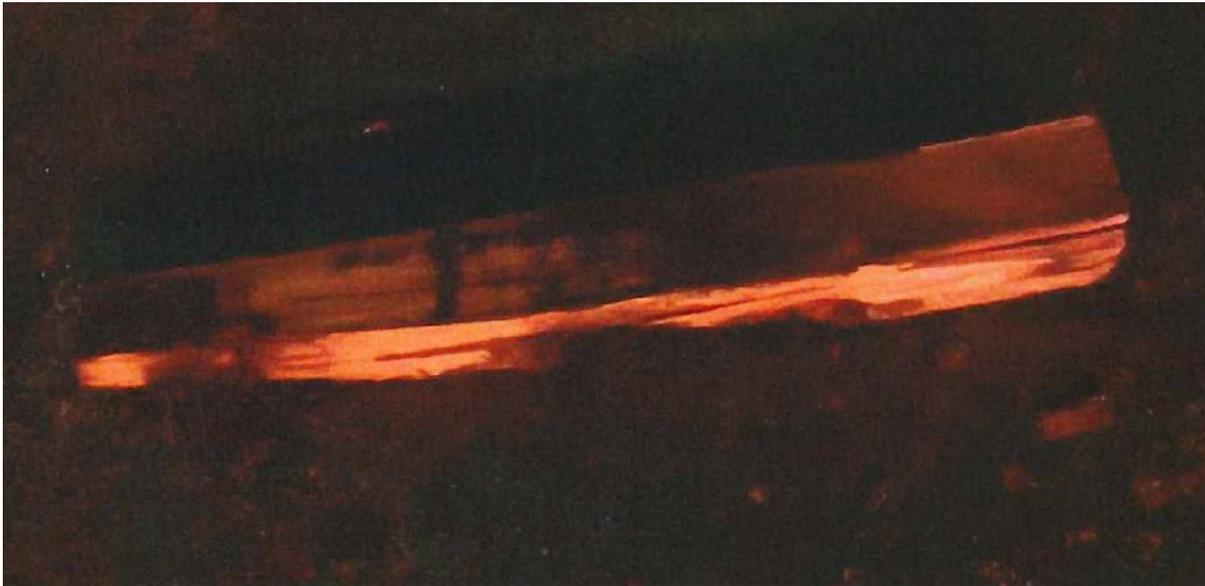
The vessel's heave and movement and the vibration caused from the 'slamming' appears to have weakened the bolted integrity of the timber chocks, resulting in a section splitting away and falling to the deck below.

The shock waves moving thorough the after end of the vessel caused a stress point between the bolts securing the wood section to the crutch and the wood itself. This can be seen from the split down the wood and the lack of any rotting or degradation of the wood section itself.

**Block of timber which fell to deck**
