Safety Alert

Number: 17-04

Subject: Battery Fire

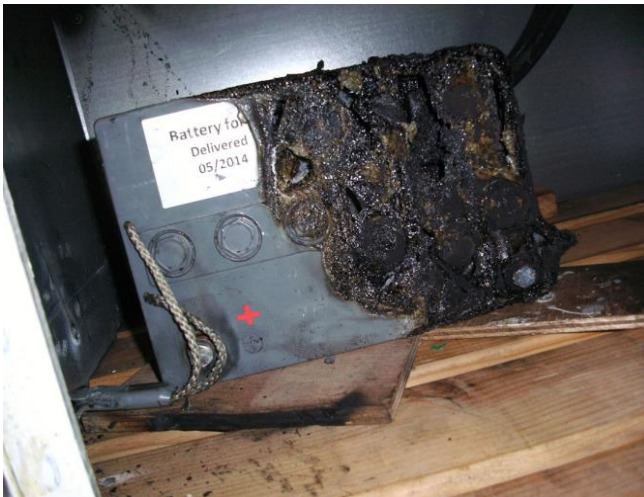
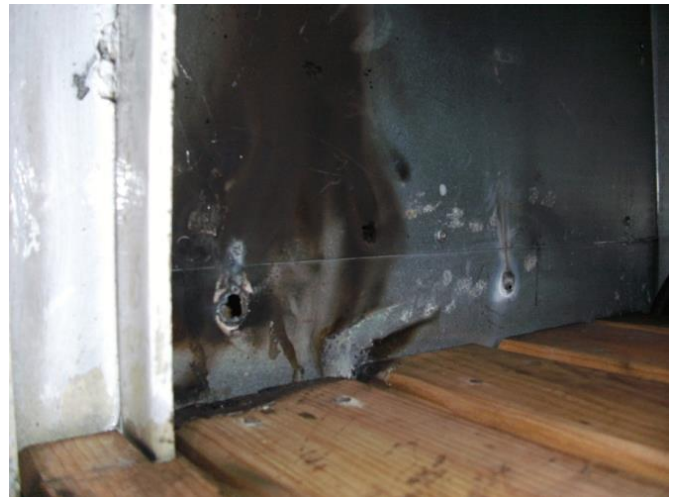
Photographs / Supporting Information

In the early hours of the morning during a period of adverse weather the fire alarm in the vessel battery locker was activated. The crew mustered and fire team assembled, upon investigation it was discovered that there was small flame and sparks being emitted from a spare battery that was stored in the battery locker on the top shelf.

The battery had been delivered during previous port call and stored within the battery locker. Unfortunately, it had been placed on a storage shelf with no attempt to secure it in place.

During a period of heavy weather, the battery tipped onto its side and slid against the steel lining of the bulkhead.

As the battery terminals were not covered, this caused the battery to short and led to it overheating.

Once the battery had reached ignition temperature, the casing melted, setting off the fire alarm.

- All batteries, including spares, must be secured in place to prevent movement
- All spare batteries should have the terminals covered with insulating material to prevent accidental shorting
