Safety Alert

Number: 18-04

Subject: Finger Injury During Recovery of Daughter Craft

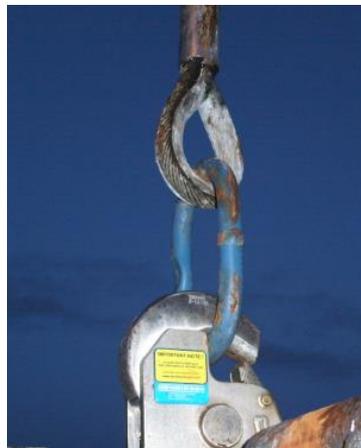
Photographs / Supporting Information

Whilst the vessel was recovering the Daughter Craft after a Man Overboard exercise the Boatman took hold of the lifting ring, it was when he hooked the ring into the DC hook his left index finger became caught between the lifting ring and the lifting wire thimble, resulting in injury to the finger.

- The lifting wire's thimble diameter allows the thimble to freely move all around the lifting ring. Therefore, even if the ring is grabbed by the boatman in the middle, to keep his fingers away from pinch hazards arising from the hook and the wire's thimble (as it was at the time of the incident), the thimble can move close to his fingers increasing the likelihood of them being trapped.
- The procedure and risk assessment used for the task did not state clearly when the davit's light tension mode can be engaged and what technique must be used by the aft boatman when he inserts the lifting ring into the rescue craft hook.
- Experience of the IP at inserting the lifting ring into the craft's hook may have contributed to the incident.

1. The management is currently looking into available options of lifting rings that could provide a better protection to the boatmen's hands and fingers during inserting of the lifting ring it into the rescue craft hook by preventing the wire's thimble from free movement. Once the decision has been made the fleet will be informed.

2. All vessels are to conduct a review of their risk assessments and specific procedures for operation of rescue crafts and amend them if and when required. The procedure and risk assessment must clearly state that the light tension mode (if available) can be only engaged by the davit operator when he receives a clear signal form the boatman after he clears his hands from the lifting equipment.
